'ŌPAEKA'A BRIDGE REHABILITATION

LOCATION District of Kapaa, Kauai, HI
OWNER County of Kauai - DPW
 Island of Kauai, HI
FIRM KAI Hawaii, Inc., Honolulu, HI

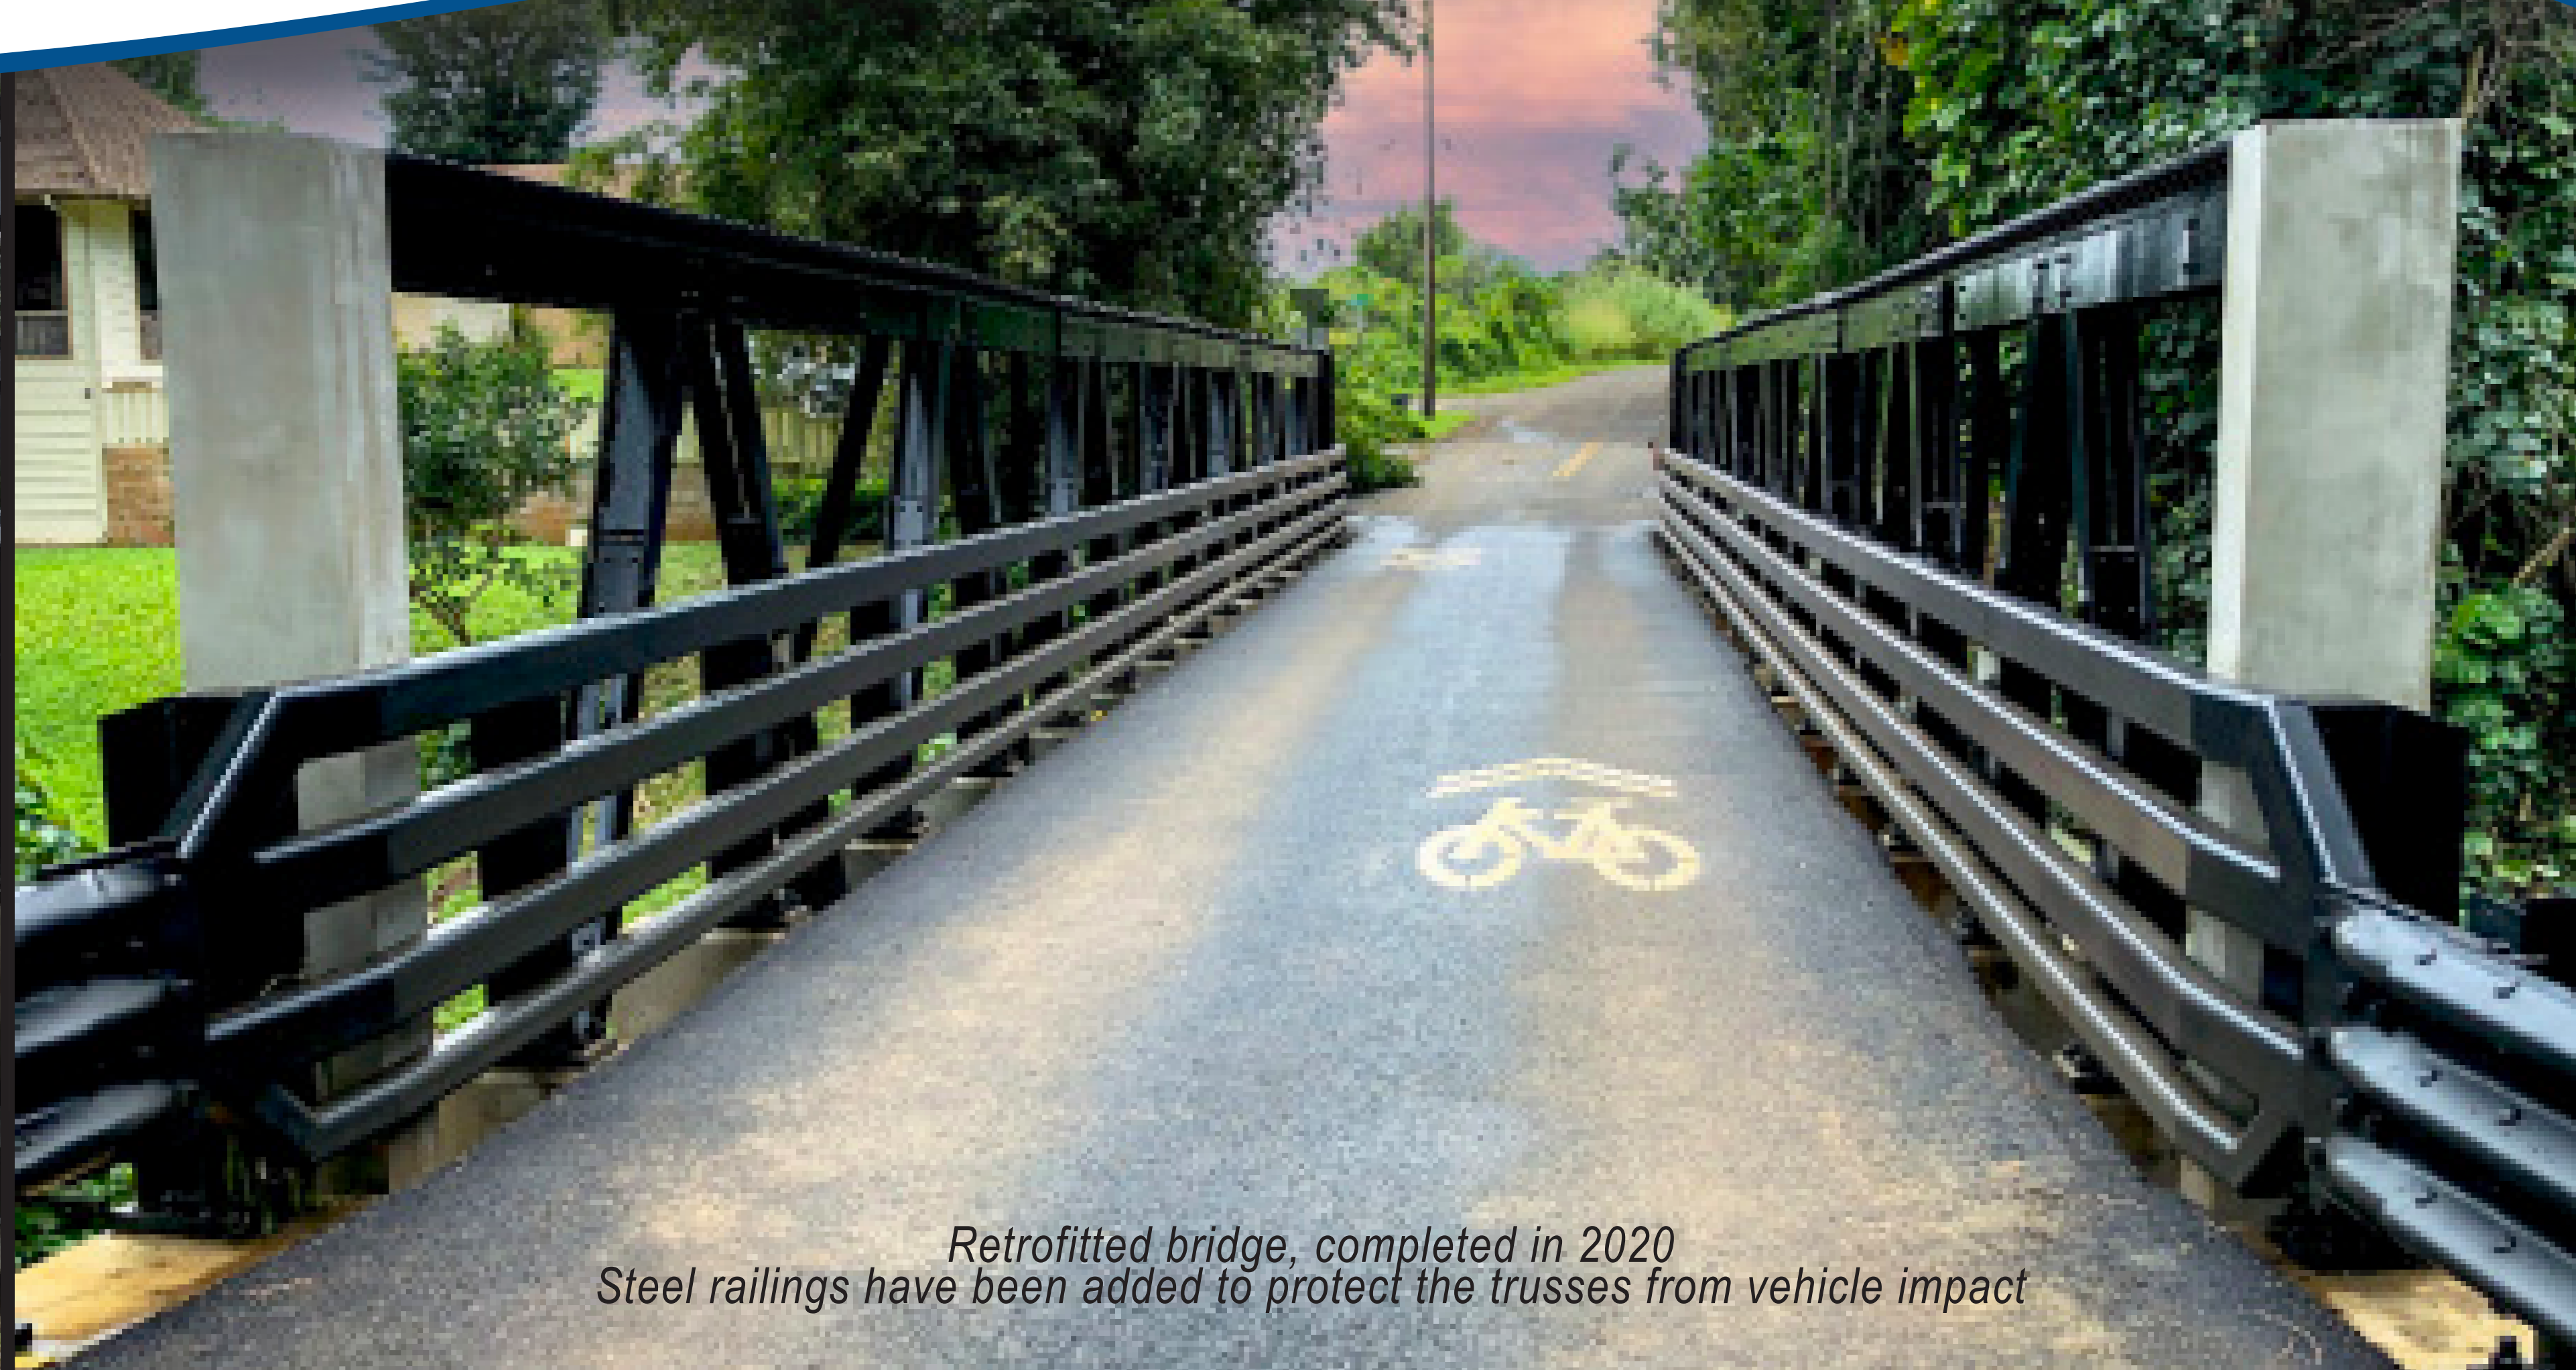
*Retrofitted bridge, completed in 2020
Steel railings have been added to protect the trusses from vehicle impact*

The ultimate solution was to design a retrofitted bridge that incorporates the original steel trusses giving the 'Ōpaeka'a Bridge its iconic 19th century aesthetic appearance, while maintaining its historic integrity. Retrofitting/repairing old steel trusses for reuse is sustainable, but it is unique and has rarely, if ever, been accomplished for a bridge in Hawaii as old and severely damaged as this one. This is because the design and construction was costly, complex, and challenging.

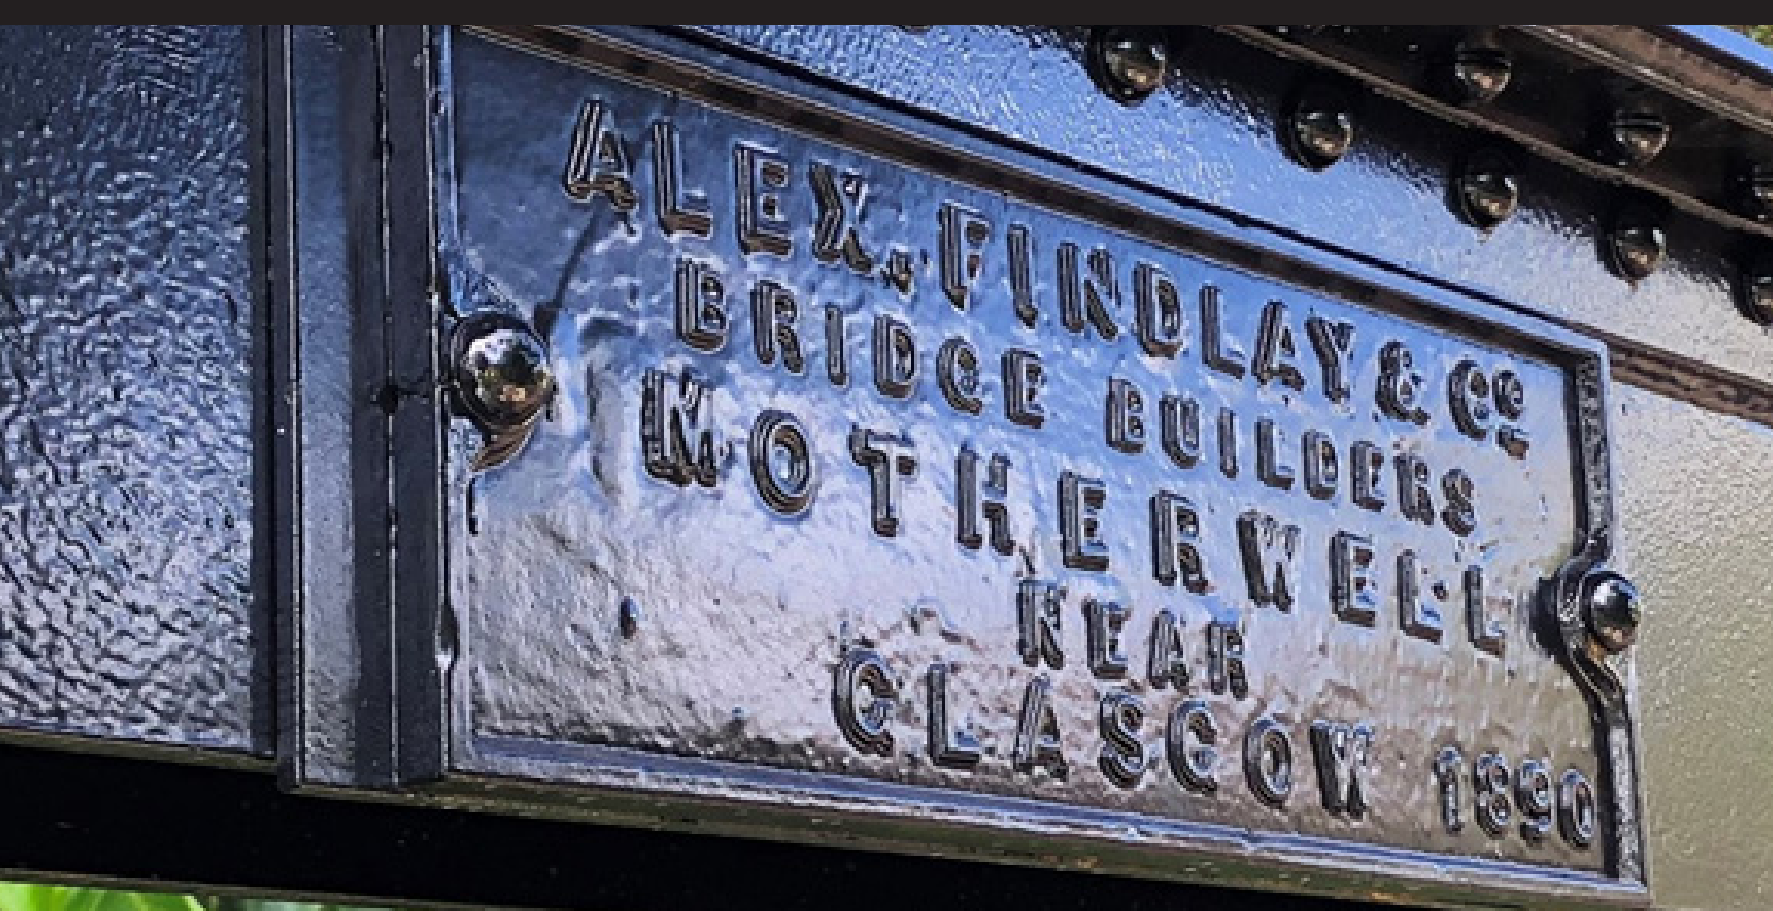
Original plaque that is attached to the top truss chord

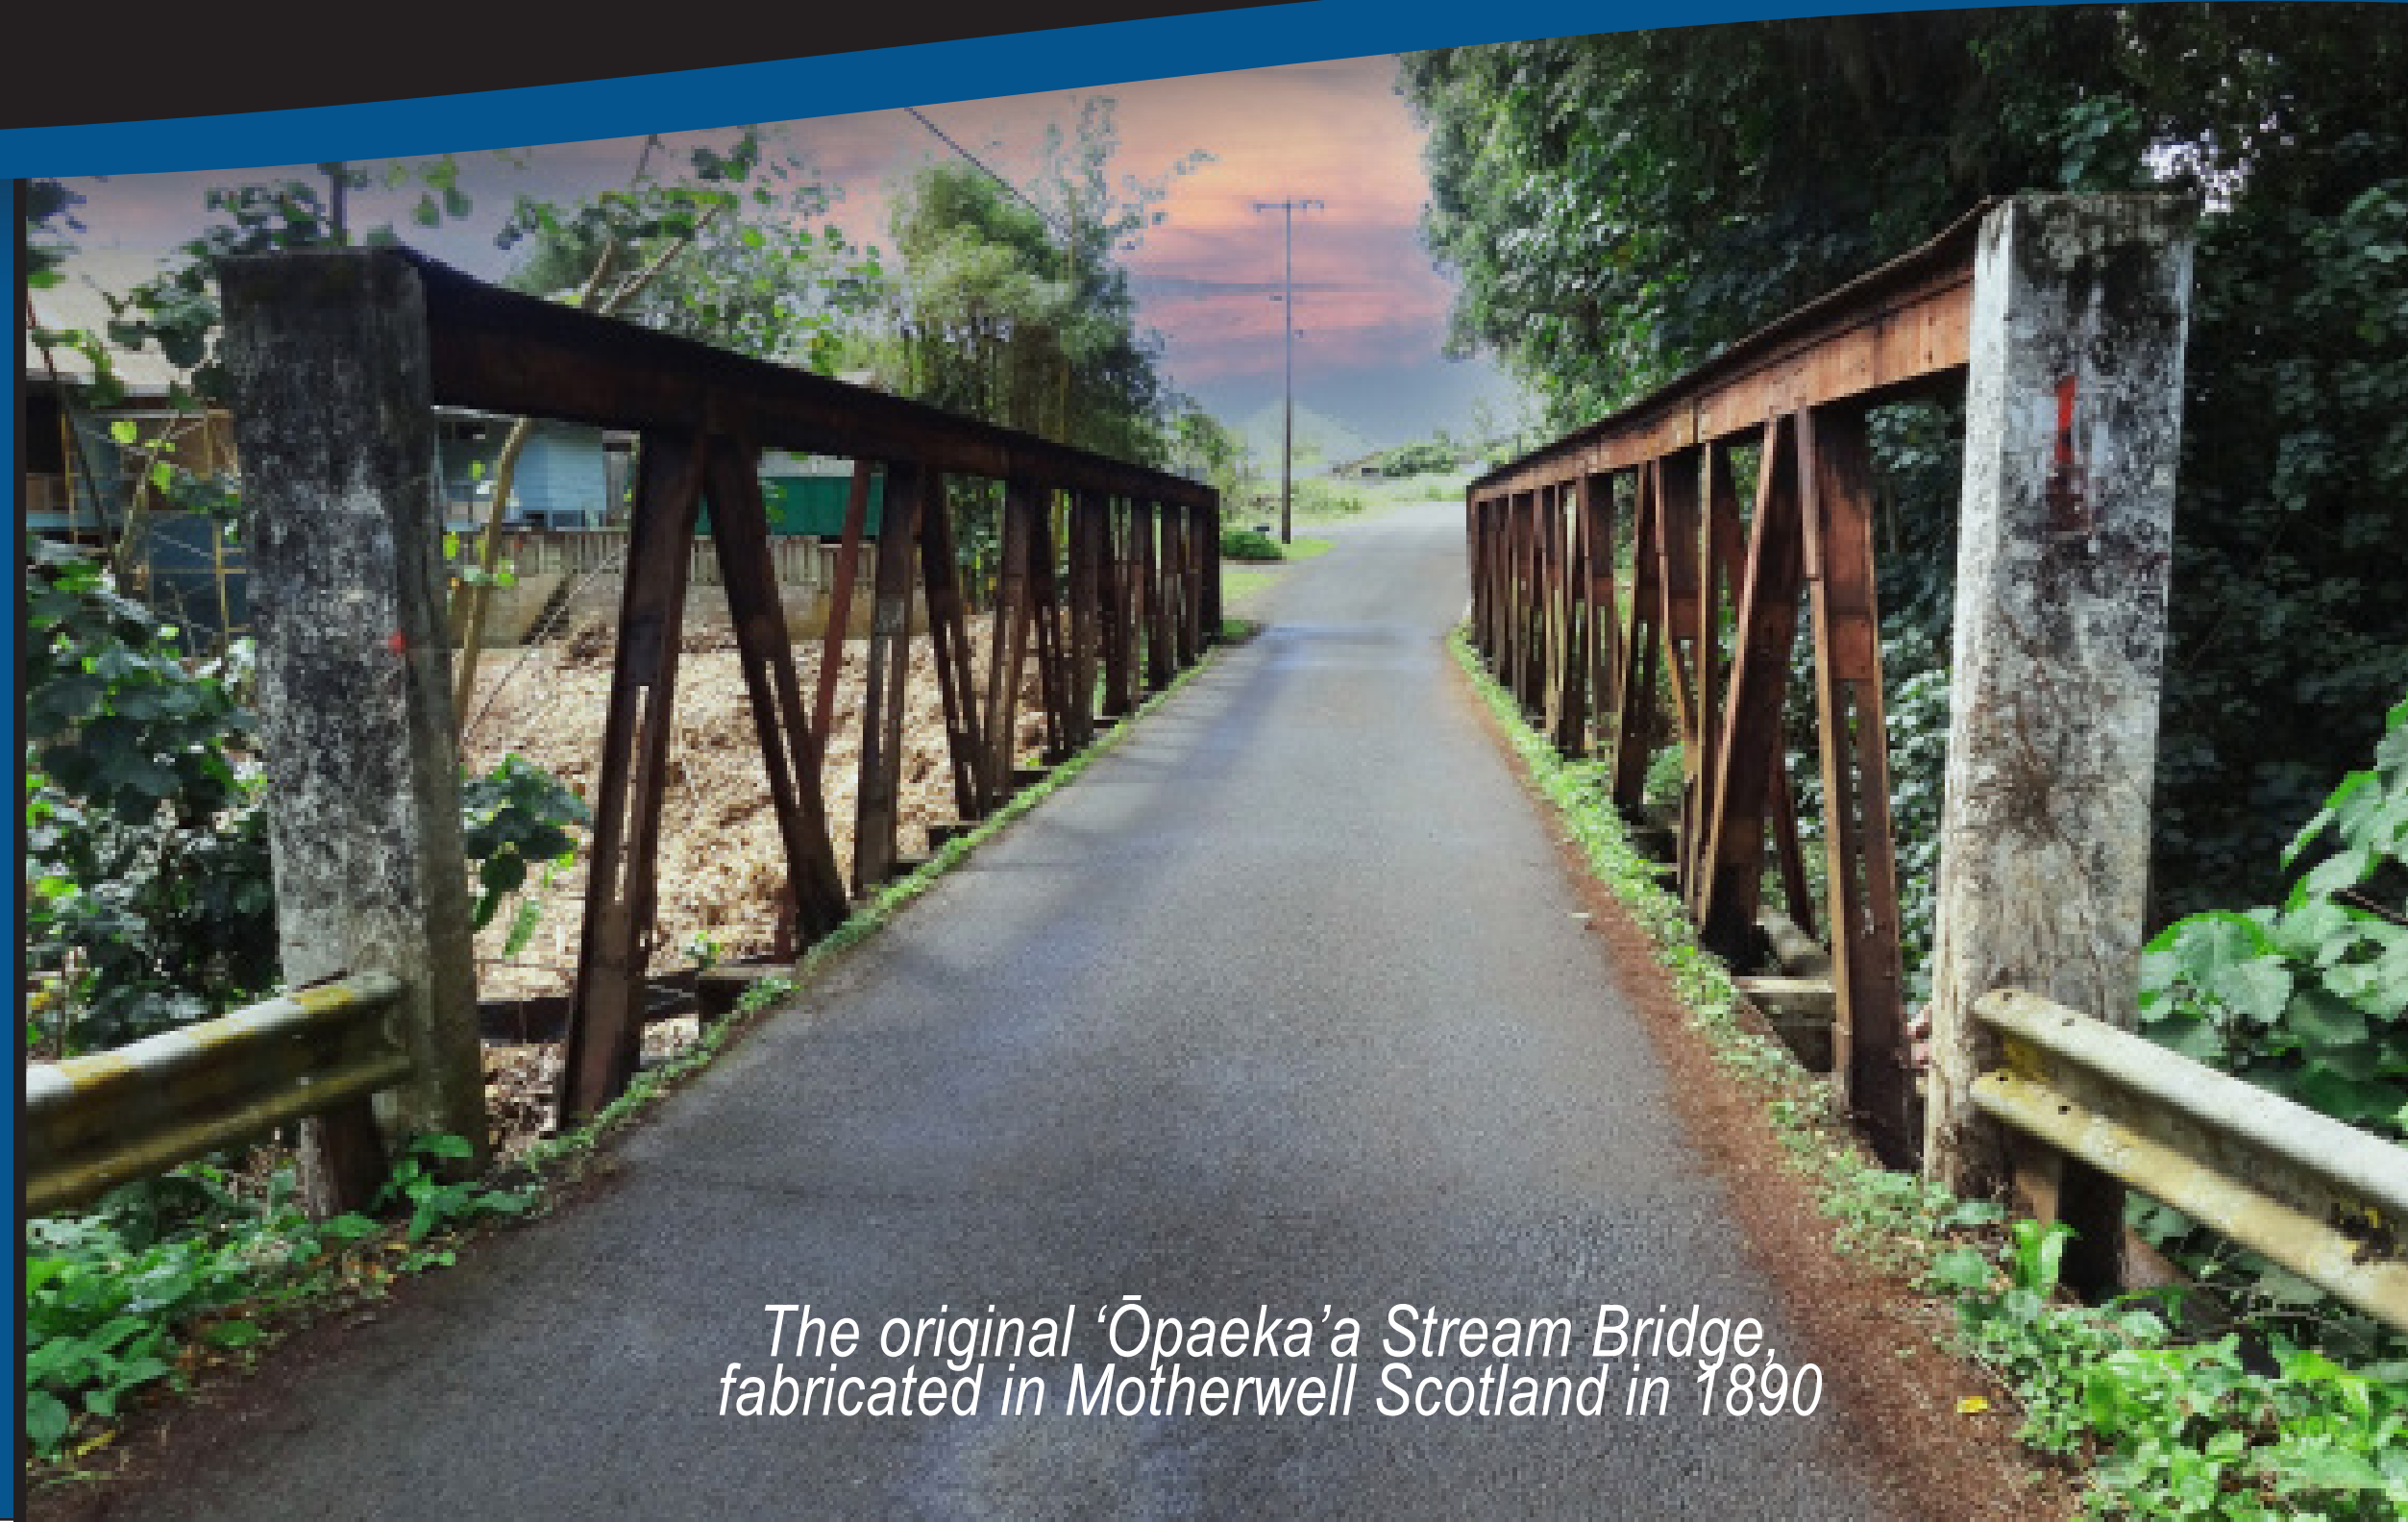
The original 'Ōpaeka'a Stream Bridge, fabricated in Motherwell Scotland in 1890

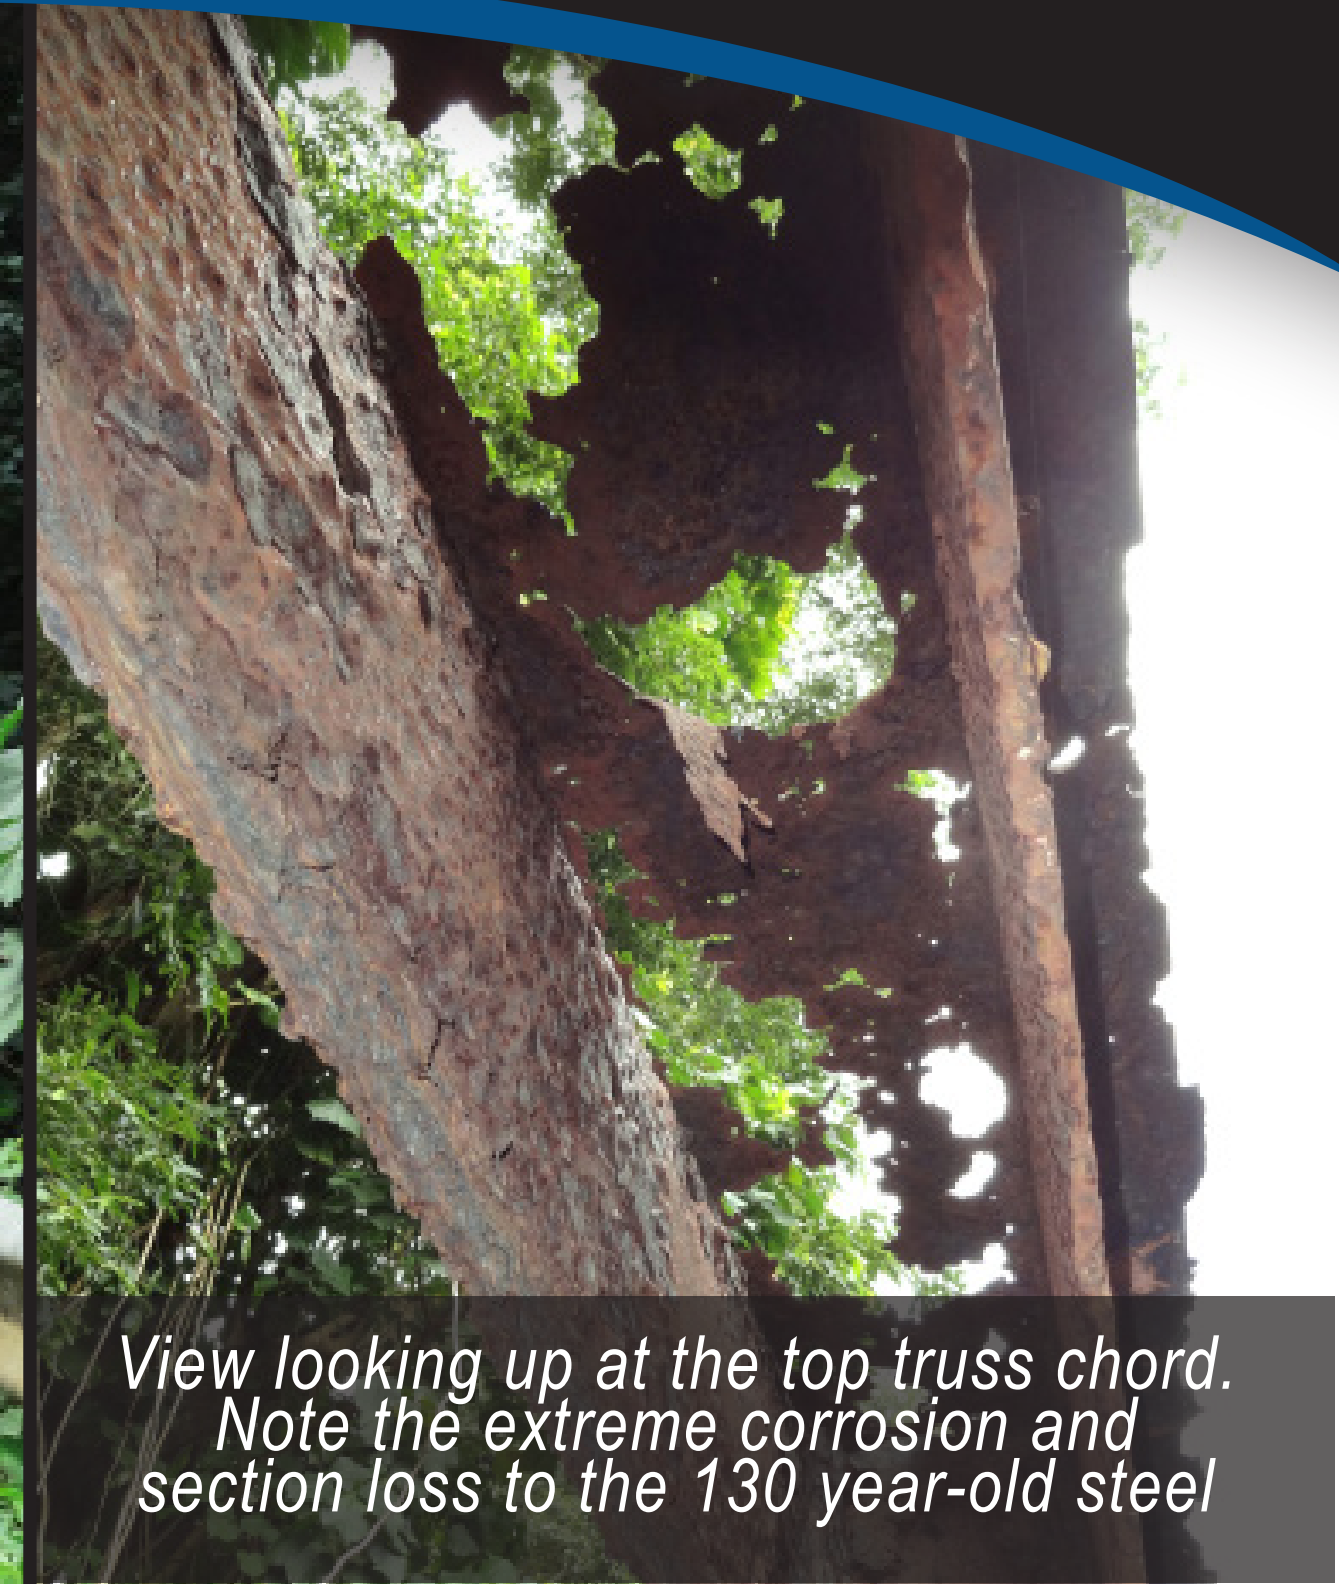
View looking up at the top truss chord. Note the extreme corrosion and section loss to the 130 year-old steel
